Manhole Inspection Summary

Manhole # S07KK1014MH

Insp Date: **1/20/09 2:54 PM**

Location Address: **REAR - 3740 MANCHESTER AVE**

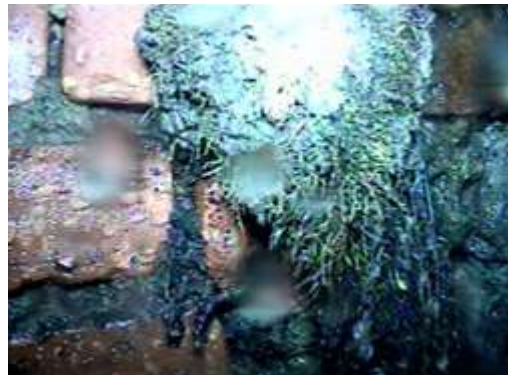
Defect 2

I9 SEAL INFILTRATION - ROOT BALL

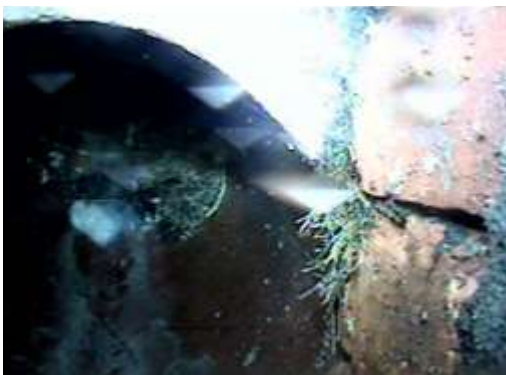
Defect 1

I6 SEAL INFILTRATION- ROOTS FINE

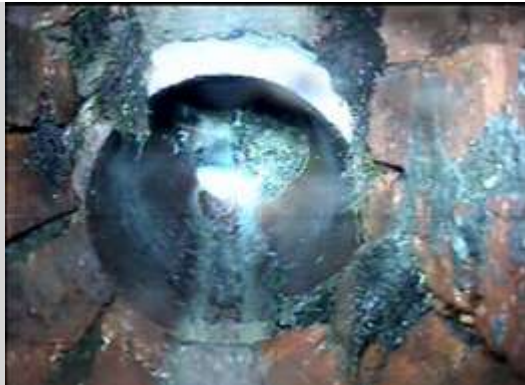
6 O'Clock Inflow

Infiltration: **Evidence** Pipe Seal Cond: **Cracked**

Connects To: **Stub connection / abandoned**

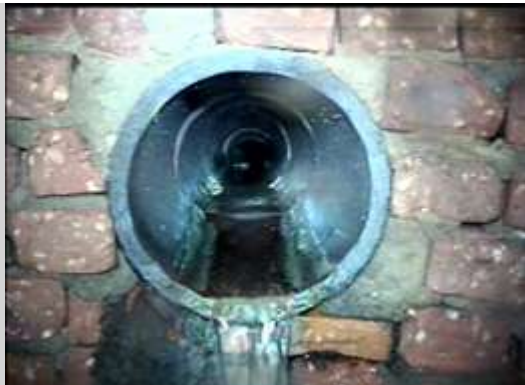
9 O'Clock Inflow

Infiltration: **Evidence** Pipe Seal Cond: **Unknown**

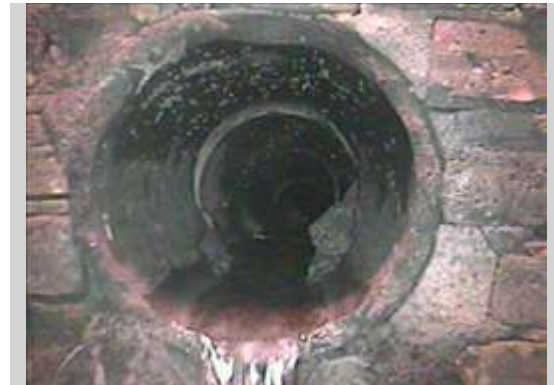
Drop In @ 9 O'Clock

Drop: **Outside Direct**

Drop Condition: **Clogged**
